Murray Darling Basin – water quality and dissolved oxygen results

Multiple agencies are undertaking water quality monitoring to review dissolved oxygen conditions across NSW, identify potential risks to ecological communities, implement mitigating measures and respond to the mass fish death event in the Darling River. This update provides a summary of information collected up to 20 April 2023.

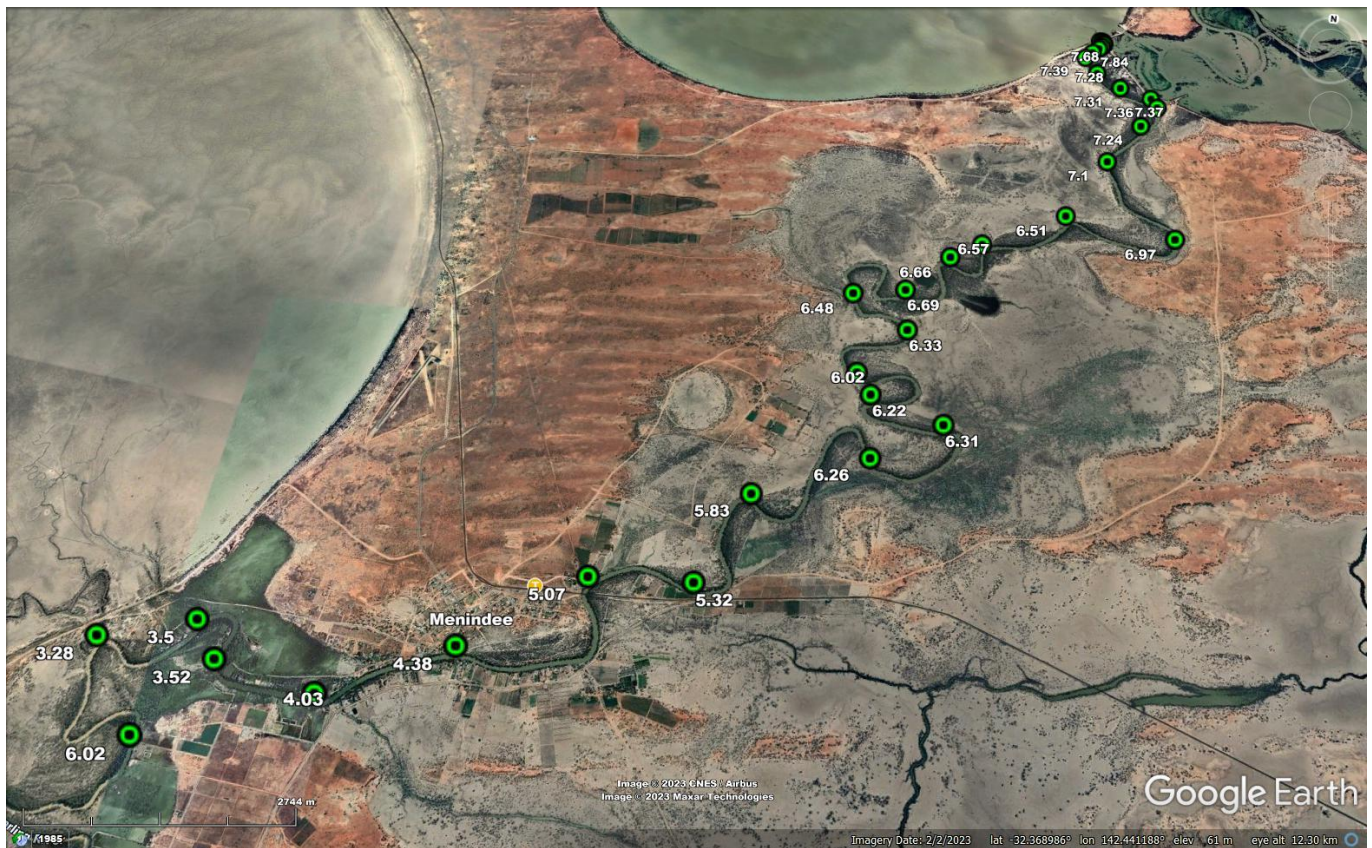
Figure 1 is a Google Earth image showing the location and results from the survey of dissolved oxygen levels down the Darling River on 20 April from Lake Pamamaroo, past Menindee town, to below where water from Menindee Lake flows into the river. The results show that there was a gradual decrease in oxygen levels with distance down the Darling River, with the lowest result recorded upstream of Menindee Creek.

Figure 1: Google Earth image showing dissolved oxygen results (mg/L) from the Lake Pamamaroo outlet to Menindee Creek on 20 April

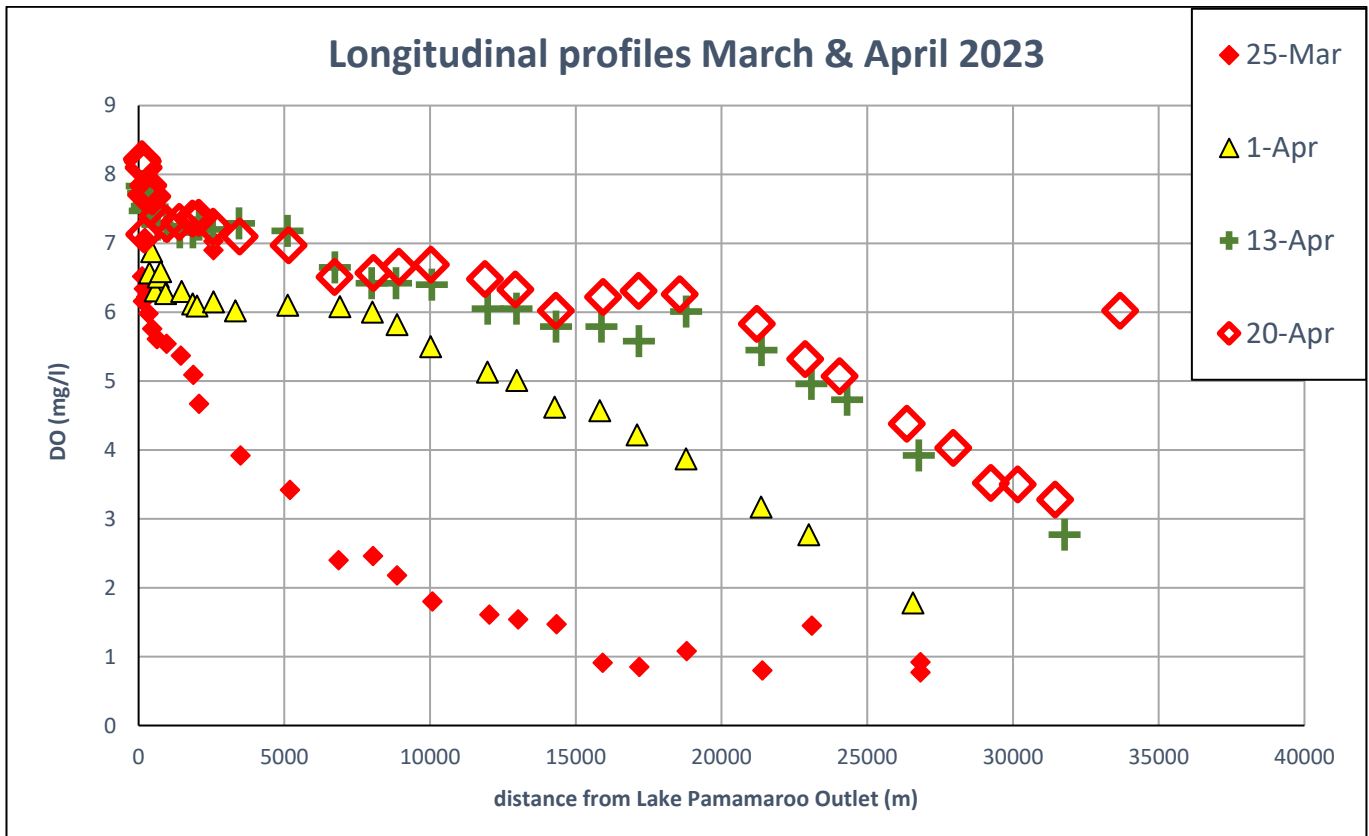
Frequent longitudinal surveys of dissolved oxygen have been undertaken down this reach of the Darling River over recent weeks. Figure 2 shows that over time, dissolved oxygen levels have been improving in response to the operational measures in place.

Figure 2: Comparison of dissolved oxygen results (mg/L) from the Lake Pamamaroo outlet to Menindee town. The most downstream measurement on the 20th of April is downstream of Menindee Creek.

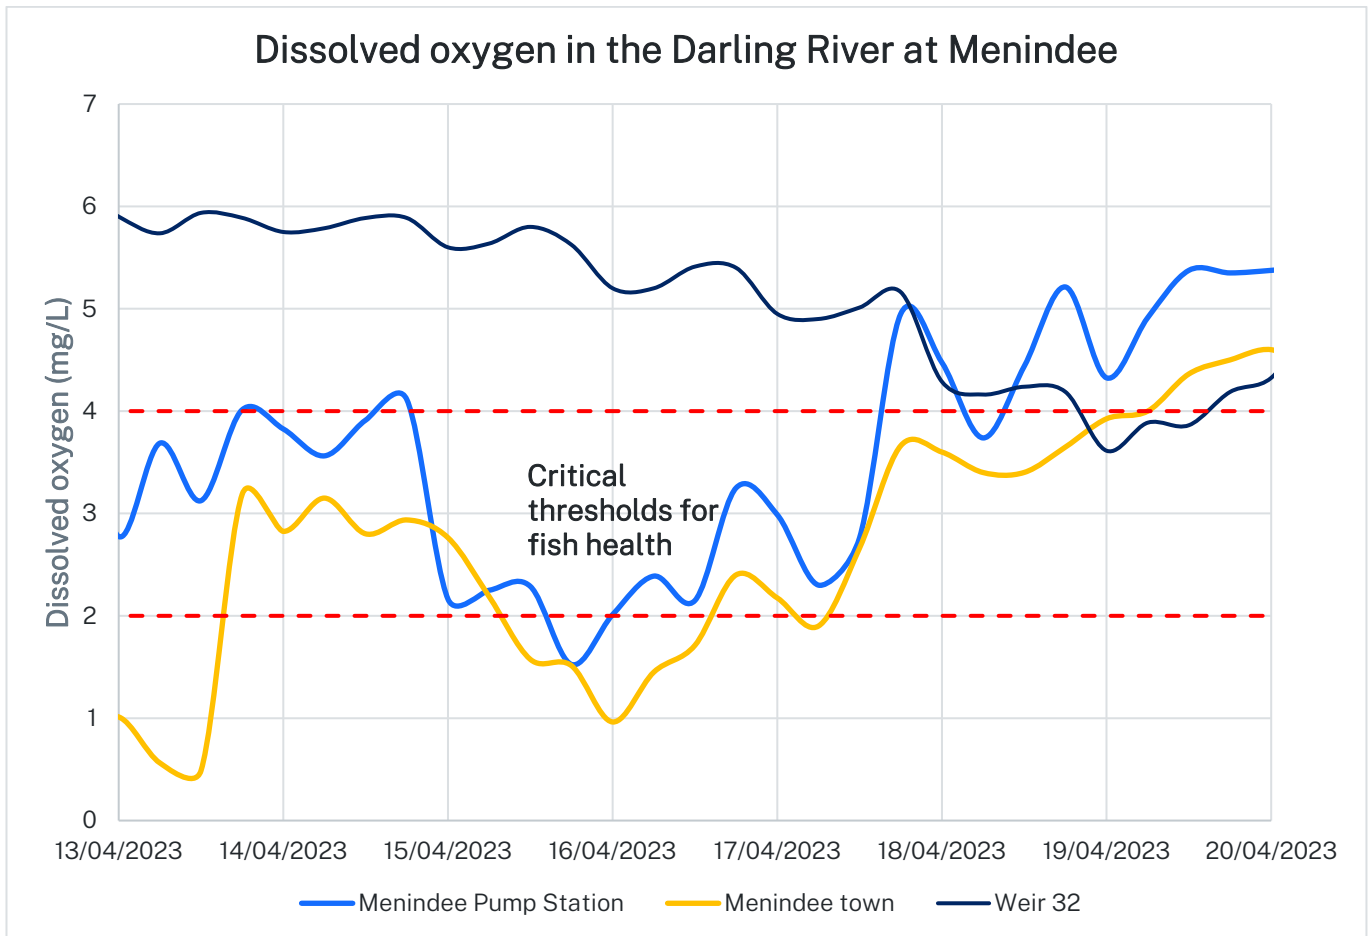
Data from WaterNSW dissolved oxygen sensors at the Menindee pump station, Menindee Town, and further downstream at Weir 32 are shown in Figure 3. These sensors are set at various depths so may not always reflect the readings taken at the water surface. They indicate daily fluctuations in dissolved oxygen, with replenishment during the day but decreasing overnight. Daytime dissolved oxygen levels have been steadily increasing at the Menindee sites over the past few days. Dissolved oxygen levels at Weir 32 declined as releases from Lake Menindee were reduced.

Figure 3: Dissolved oxygen (mg/L) in the Darling River at Menindee: Menindee pump station, Menindee town and Weir 32 – 13 April to 20 April 2023

NSW and Commonwealth agencies will continue to work together and monitor dissolved oxygen levels in this area and advise the best operational measures to mitigate risks to aquatic life as much as possible. This can involve adjusting the timing, size and location of releases from the lakes into the lower Darling River to maintain the quality of the water in the river.

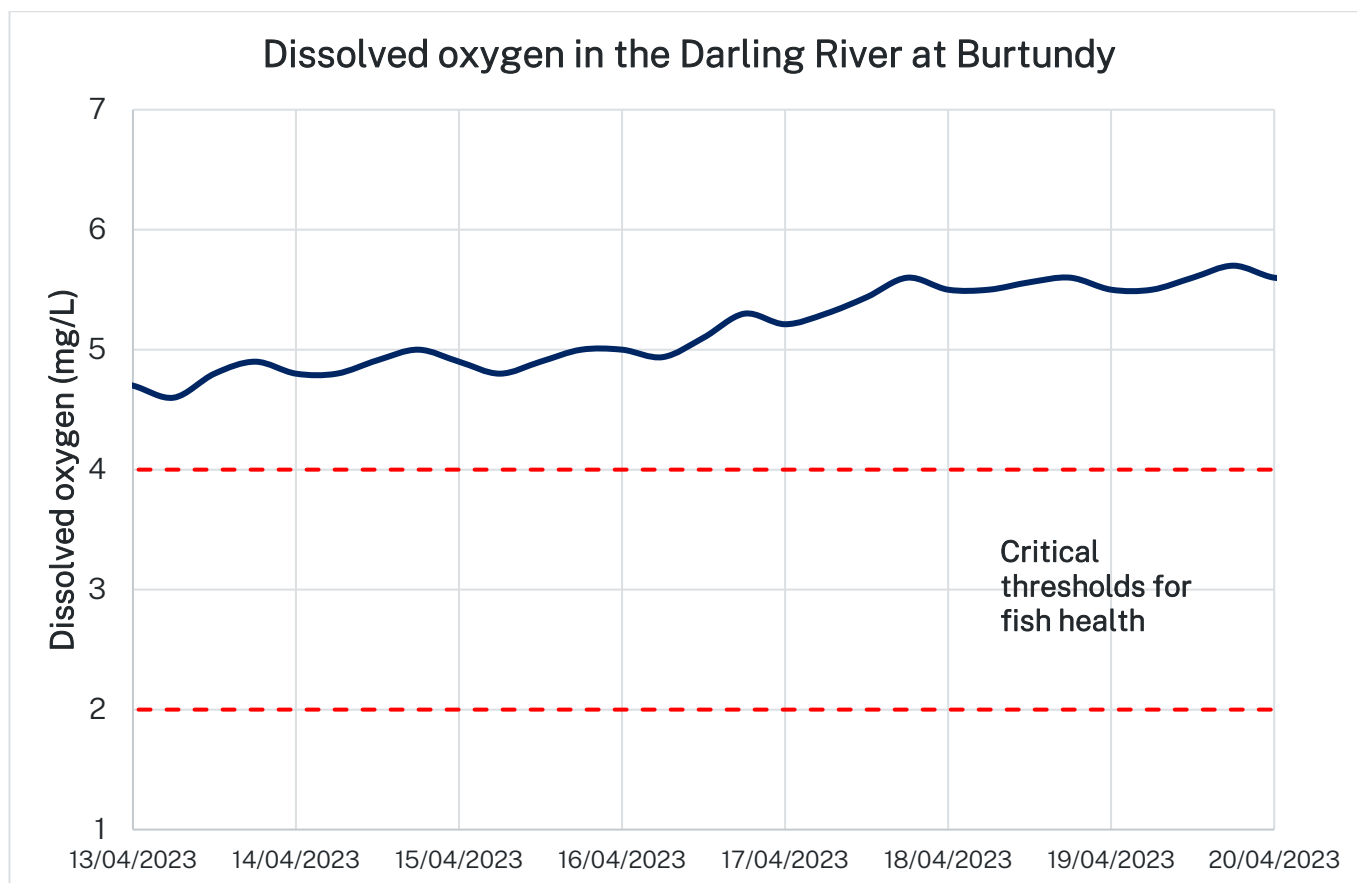
Table 1 shows recent dissolved oxygen data in the lower Darling River from Moorara (upstream of Pooncarie) down to Tapio in the Wentworth weir pool. Critical readings below 2 mg/L have been highlighted in red. Figure 4 shows dissolved oxygen results for the Darling River at Burtundy over the last 8 days. These are now above critical levels for fish health.

Figure 4: Dissolved oxygen (mg/L) in the Darling River at Burtundy – 13 April to 20 April 2023
