Assessing changes to the Snowy River channel and vegetation 2010–19

Project description

In 2019, we used a drone to take photos from the air of the Snowy River channel. We compared these against photos collected by plane in 2010 and examined changes to the river channel and vegetation at five sites.

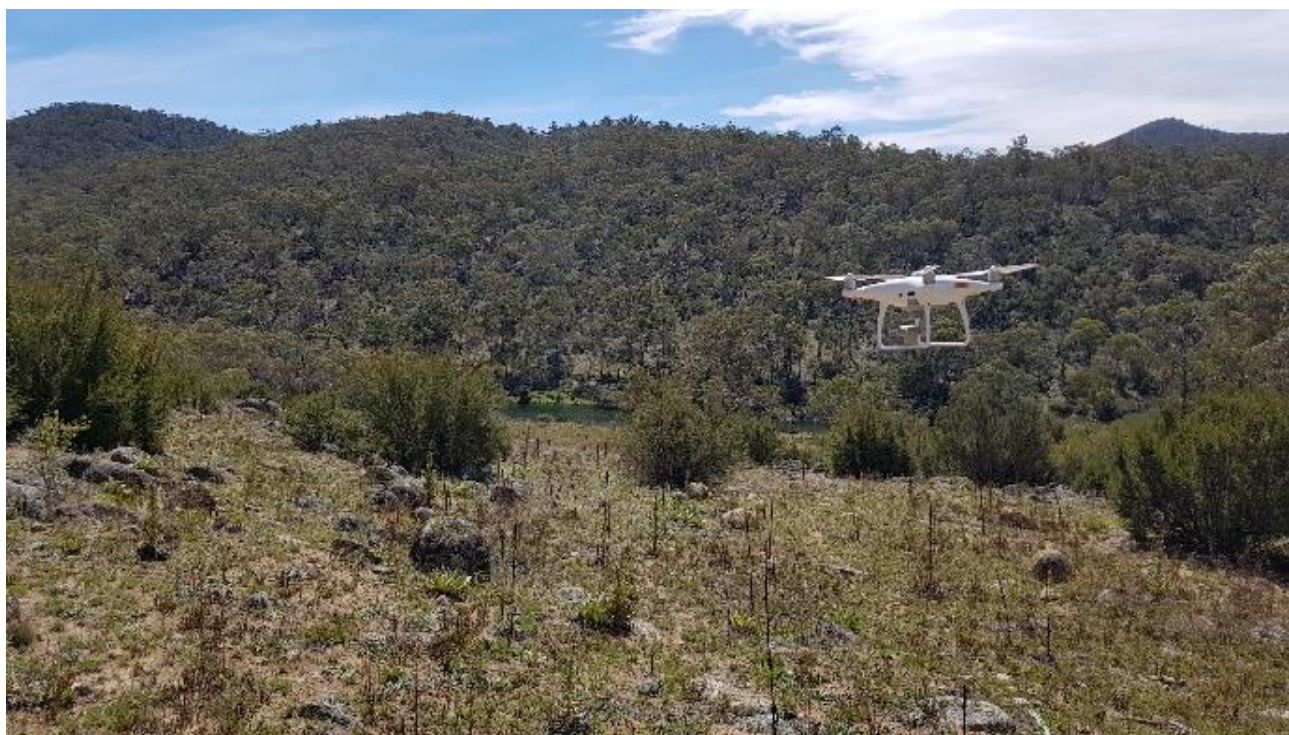
Figure 1. A drone in action over the Snowy River

In spring 2018, we trialled using a drone (Figure 1) to take photos of the large environmental water releases from Jindabyne Dam. The aim was to see if the photos were suitable for analysis and, particularly, whether the photos could be accurately positioned using mapping software. The photos obtained from the drone were more detailed than the photos taken in 2010. Although on-ground location accuracy was up to 3 m different, the trial was considered a success as these small errors are easily corrected.

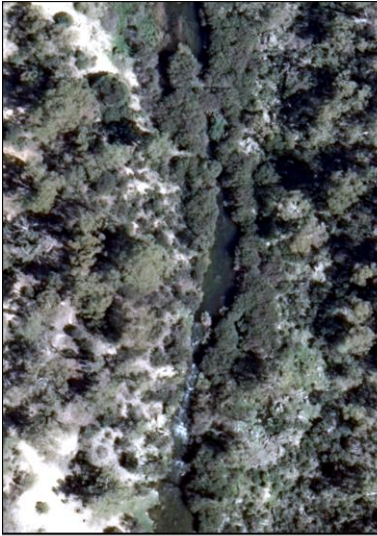
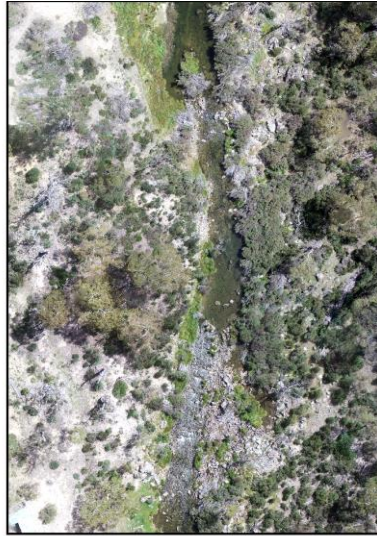
Figure 2. Photos of Site 1—Snowy River downstream of Mowamba River junction in 2010 (left) and 2019 (right). The river is adjusting to the increased flows.

Removal of vegetation from within riffles and widening of some flow channels.

Vegetation chokes the channel and causes too much sediment to build up. This reduces the amount of space for the animals that need to live in the faster flowing well oxygenated areas of the river.

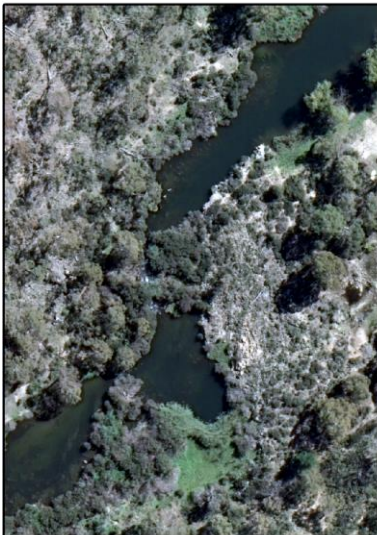
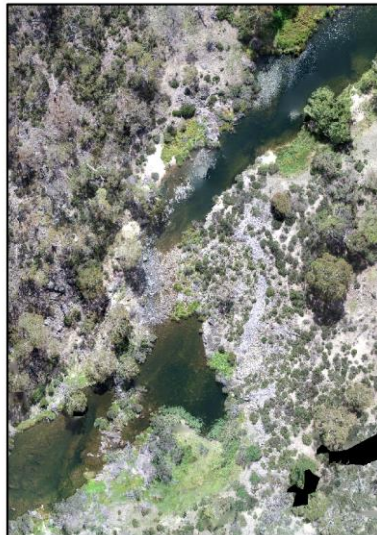
Removal of vegetation from within riffles and widening of some flow channels.

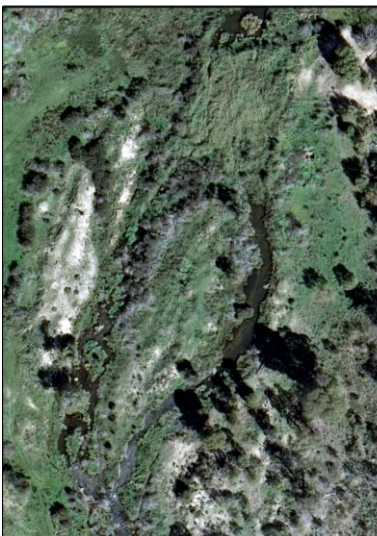
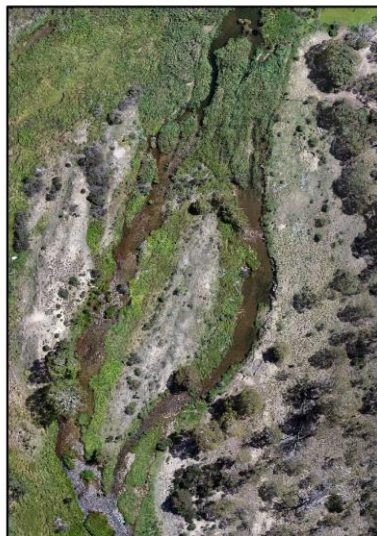
Removal of vegetation from within riffles and widening of the low flow channel.

This shows that the river is adjusting to the increased flows. Decades of little flow in the river has allowed vegetation to colonise the old river bed. The removal of this vegetation allows natural river forming processes to resume.

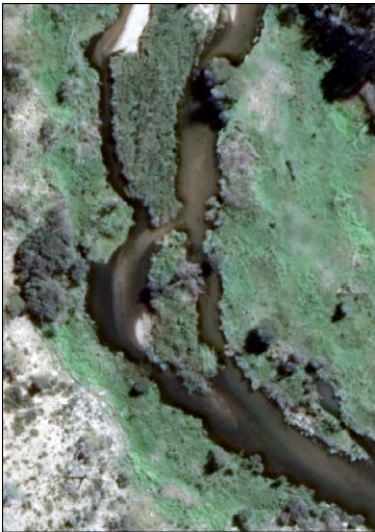
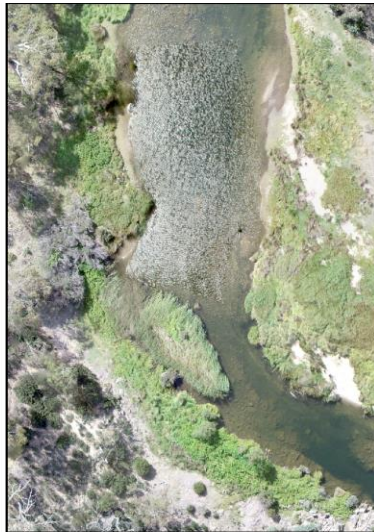
Figure 3. Photos of Site 2—Snowy River at Sugarloaf Creek in 2010 (left) and 2019 (right) showing the removal of in-channel sediment bars and in-stream vegetation

Removal of in-channel sediment bars and associated vegetation.

A large 650 m² vegetated sand bar has been removed.

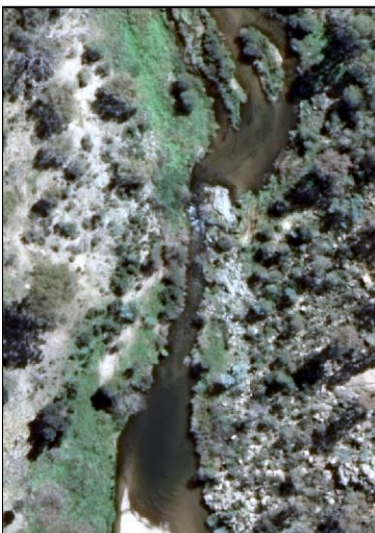
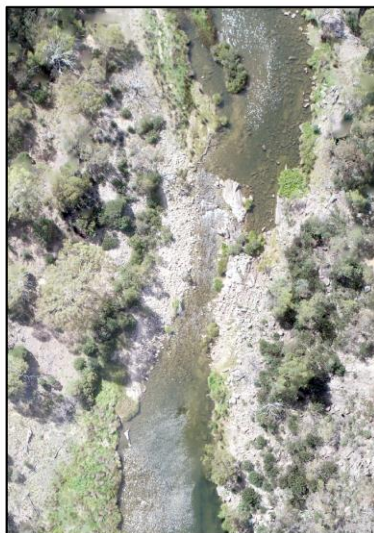
Removal of in-stream vegetation within and along riffles.

Low flow channel is wider.

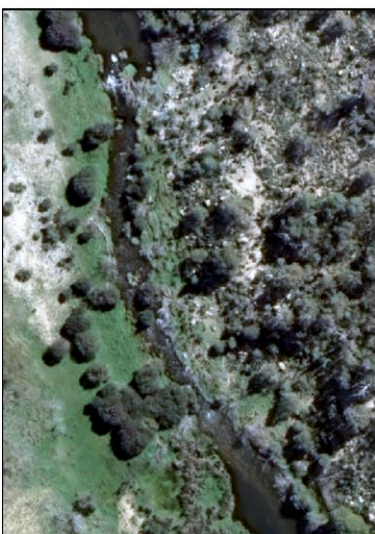
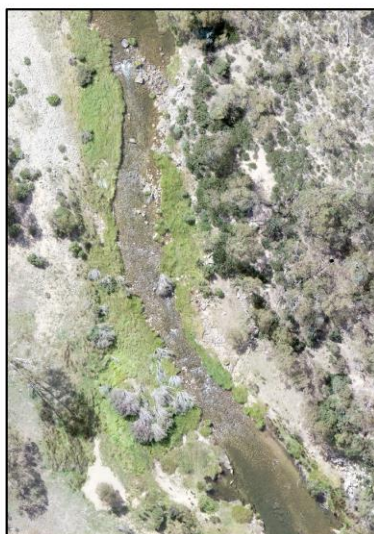
Removal of in-stream vegetation within and along riffles.

Low flow channel is wider.

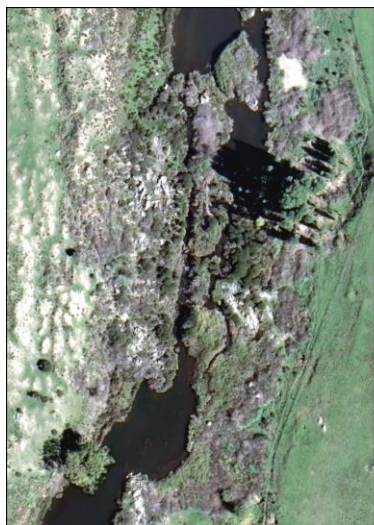
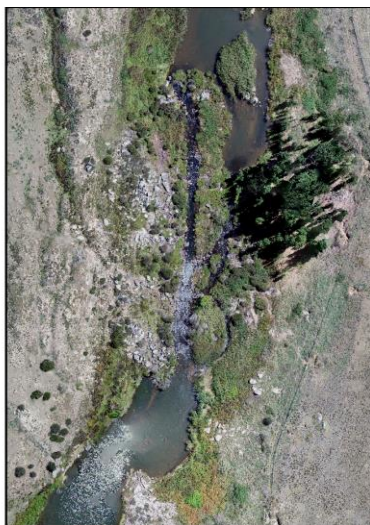
Figure 4. Photos of Site 3—Snowy River downstream of Sugarloaf Creek junction in 2010 (left) and 2019 (right)

The low flow channel has widened in some of the faster flowing sections at Site 3 although not as much as seen in some of the upstream sites.

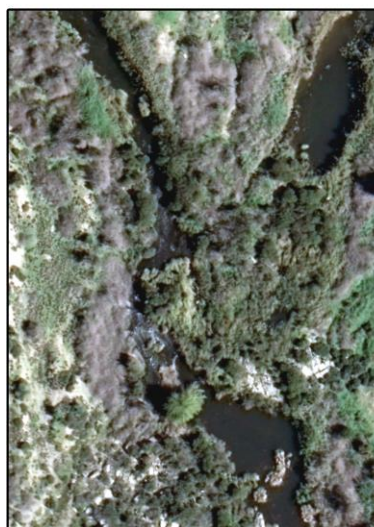
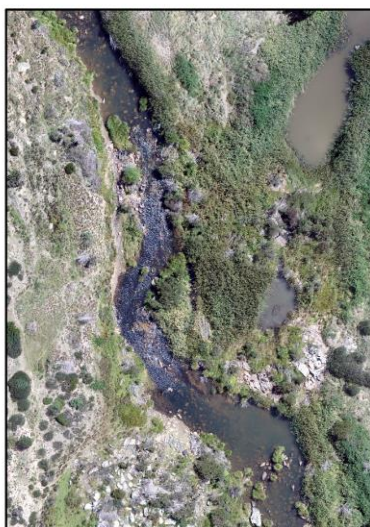
Removal of vegetation from within riffles and widening of some low flow channels.

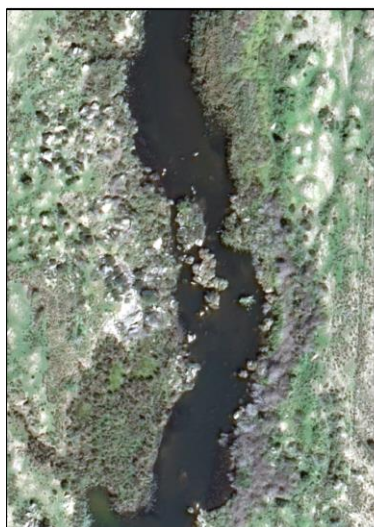
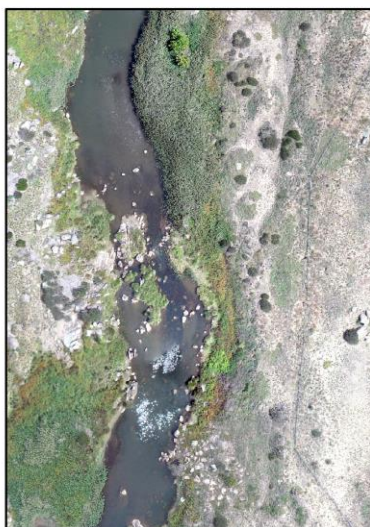
Very little change in some reaches.

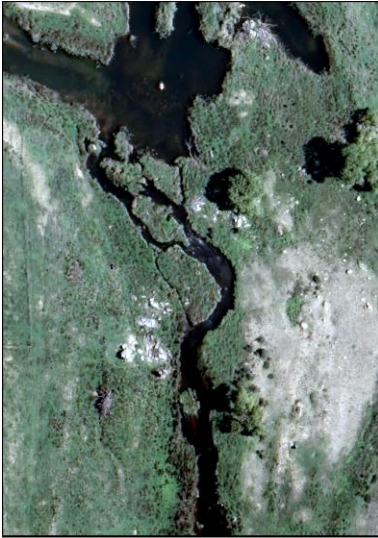
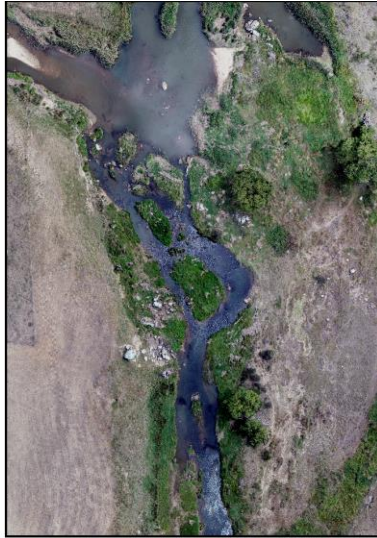
Figure 5. Photos of Site 4—Snowy River downstream of Blackburn Creek junction in 2010 (left) and 2019 (right).

Site 4 located in the Dalgety Uplands reach is one of the more responsive sites. The larger flows have caused the widening and, in some cases, deepening of the channel.

The fast flowing areas have become wider providing greater habitat areas for the animals that live there.

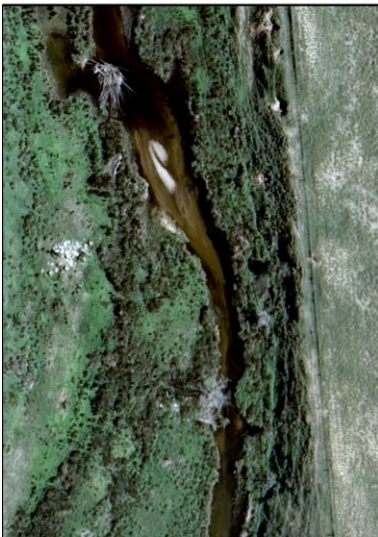
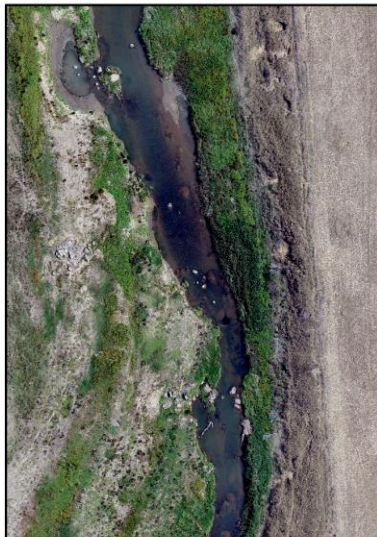
In 2010 there was evidence of sediment and sand build up in the pools and runs at this site. The sand has been removed in some areas which shows that the environmental flows are able to move bed sediments along the river.

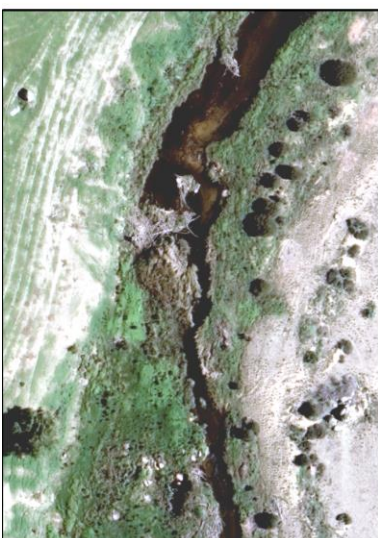
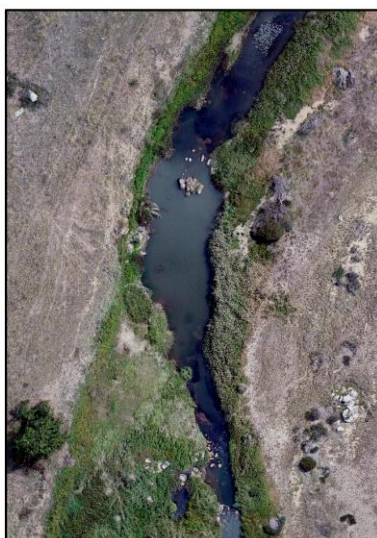
Sediment build up has been removed and the low flow channel has widened.

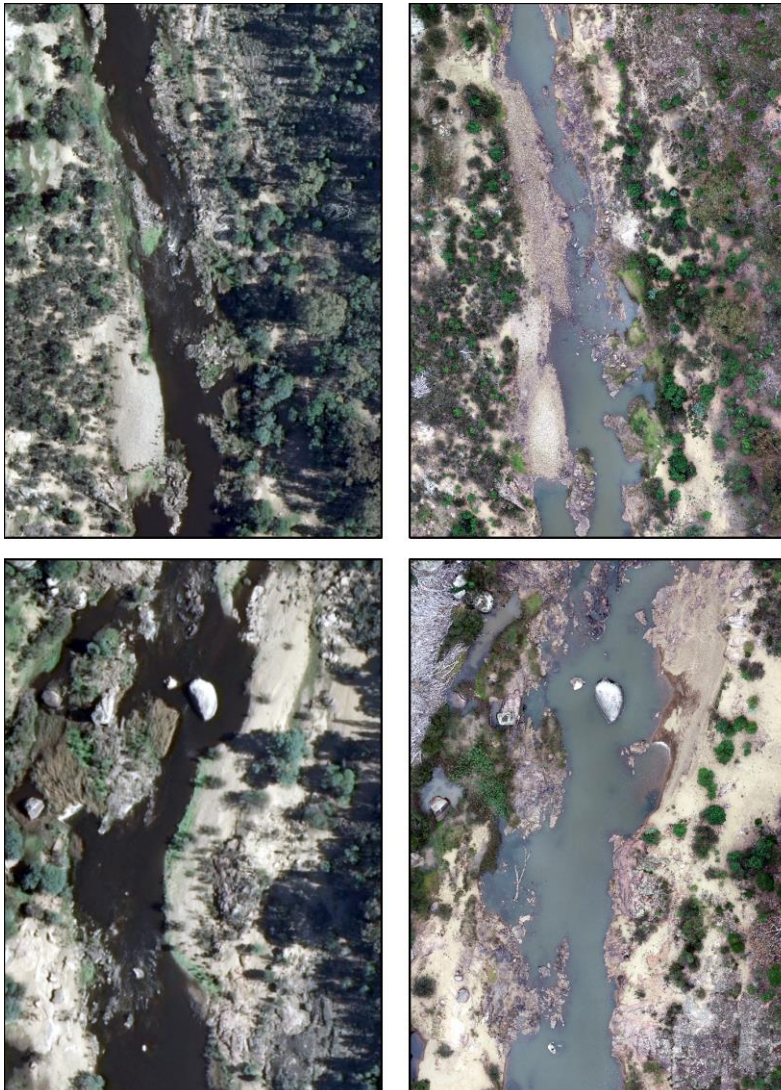
Figure 6. Photos of Site 5—Snowy River at Burnt Hut in 2010 (left) and 2019 (right)

Site 5 is located in the Burnt Hut gorge section of the river. This area is very much controlled by rocky outcrops so no large changes are to be expected in the physical condition of the river, at least at the middle range flows provided by the environmental releases.

In 2012, a 64000 megalitre flood flowed from the Delegate River into the Snowy just upstream of the Burnt Hut site. This flow is about 6-8 times the maximum environmental flow. This event removed a large sandbar and a small riffle. The changes are evident in the photos and were confirmed by field inspection at the time.
