# Murray Darling Basin – water quality and dissolved oxygen results

Multiple agencies are undertaking water quality monitoring to review dissolved oxygen conditions across NSW, identify potential risks to ecological communities, implement mitigating measures and respond to the mass fish death event in the Darling River. This update provides a summary of information collected up to 19 June 2023.

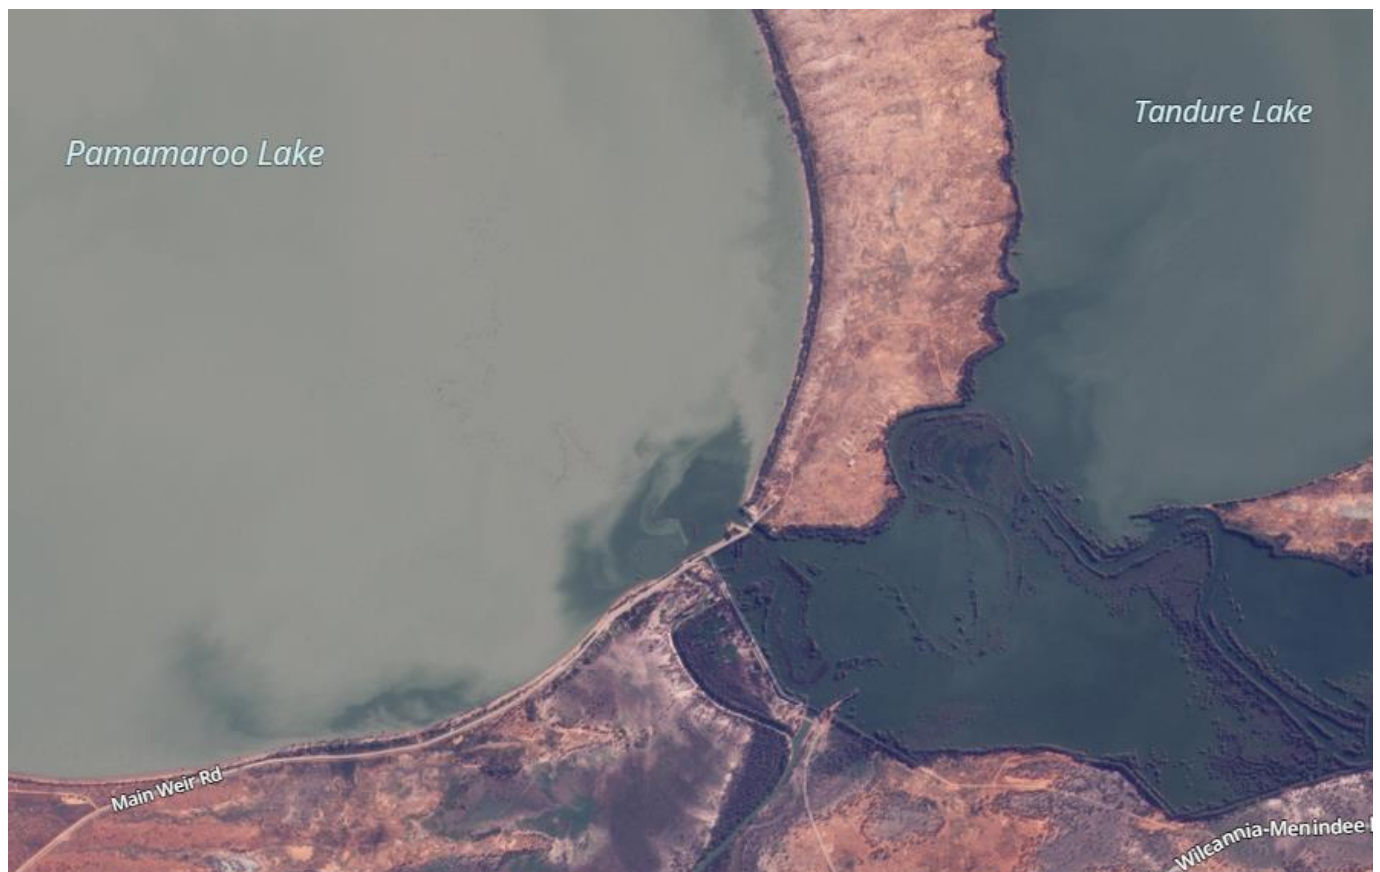
Figure 1: Planet satellite image showing water from Lake Wetherell entering Lake Pamamaroo through the Pamamaroo inlet – 17 June 2023

Pamamaroo has been closed since late March. The difference in water levels between the two lakes reached the stage where this inlet had to be reopened. A Planet satellite image from 17 June shows the green coloured, less turbid water from Lake Wetherell pushing through the inlet into the more turbid water of Lake Pamamaroo (Figure 1). Monitoring in Lake Wetherell prior to opening the inlet showed that dissolved oxygen levels had improved since March.

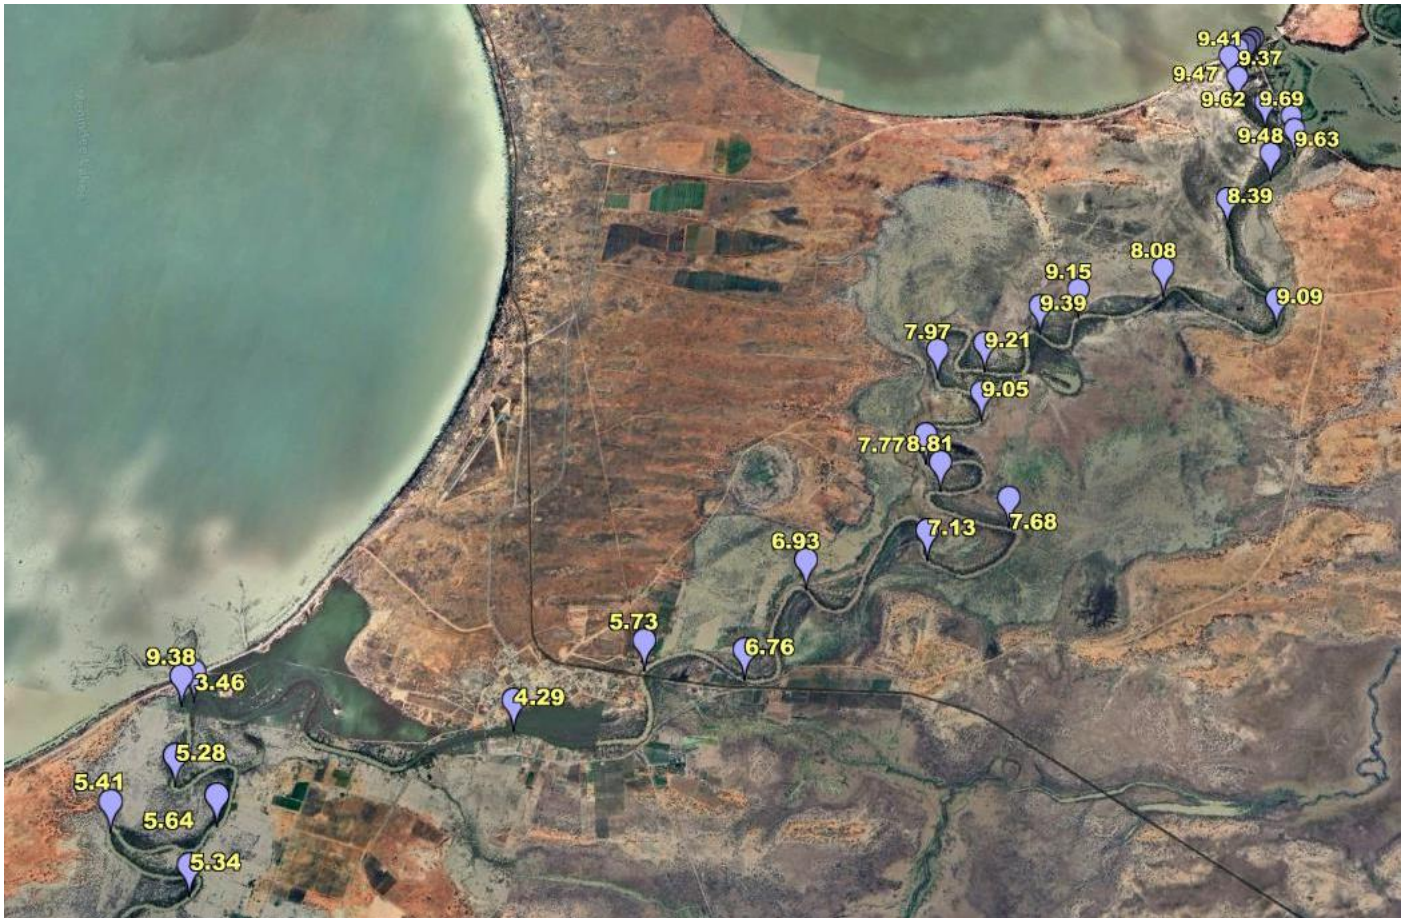
Figure 2 is a Google Earth image showing the location and results from the survey of dissolved oxygen levels down the Darling River on 14 June from Lake Pamamaroo, through Menindee town and down past the junction with the inflow from Lake Menindee. The results show that there was a gradual decrease in oxygen levels with distance down the Darling River, with a more rapid decline downstream from the Menindee railway bridge. The lowest result was immediately upstream of the Darling River-Menindee Creek junction (3.46 mg/L). Dissolved oxygen levels improve again following dilution by the oxygenated water being released from Lake Menindee. As a general guide, native

Figure 2: Google Earth image showing dissolved oxygen results (mg/L) from the Lake Pamamaroo outlet to downstream of the Darling River-Menindee Creek junction on 14 June 2023

fish and other large aquatic organisms require at least 2 mg/L of dissolved oxygen to survive but may begin to suffer if levels are below 4 to 5 mg/L for prolonged periods.

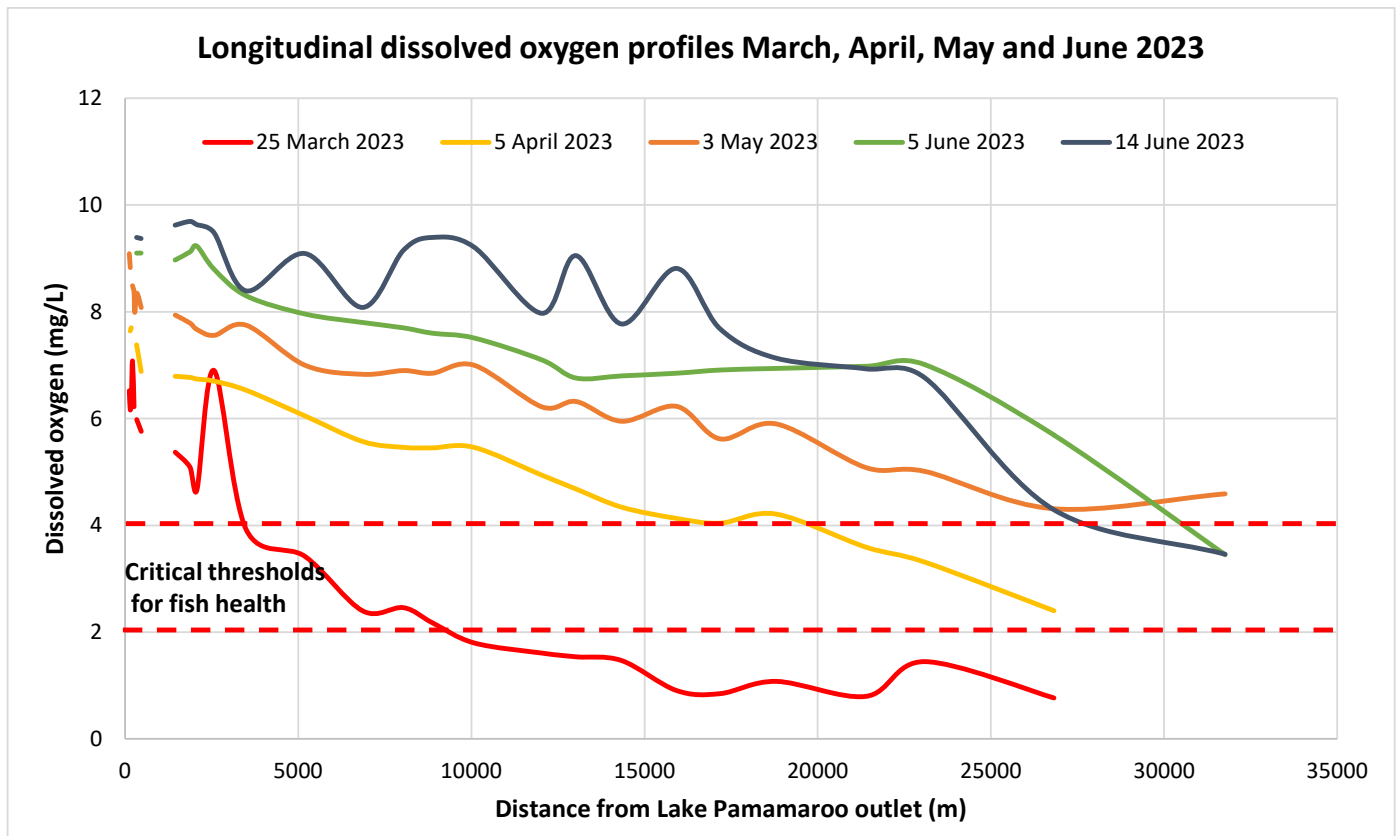
Frequent longitudinal surveys of dissolved oxygen have been undertaken by WaterNSW down this reach of the Darling River. Figure 3 shows that dissolved oxygen levels have improved since the initial profile undertaken on 25 March. Dissolved oxygen levels increased in April but were still below the critical threshold for fish health of 4 mg/L in the vicinity of Menindee town. During May, oxygen levels improved to above 4 mg/L. The most recent survey undertaken on 14 June shows oxygen levels are remaining above critical levels for fish health for most of this reach apart from immediately upstream of the Darling River-Menindee Creek junction.

Figure 3: Comparison of dissolved oxygen results (mg/L) from the Lake Pamamaroo outlet to Menindee town on 25 March, and to Menindee Creek on 5 April, 3 May and 5 and 14 June 2023

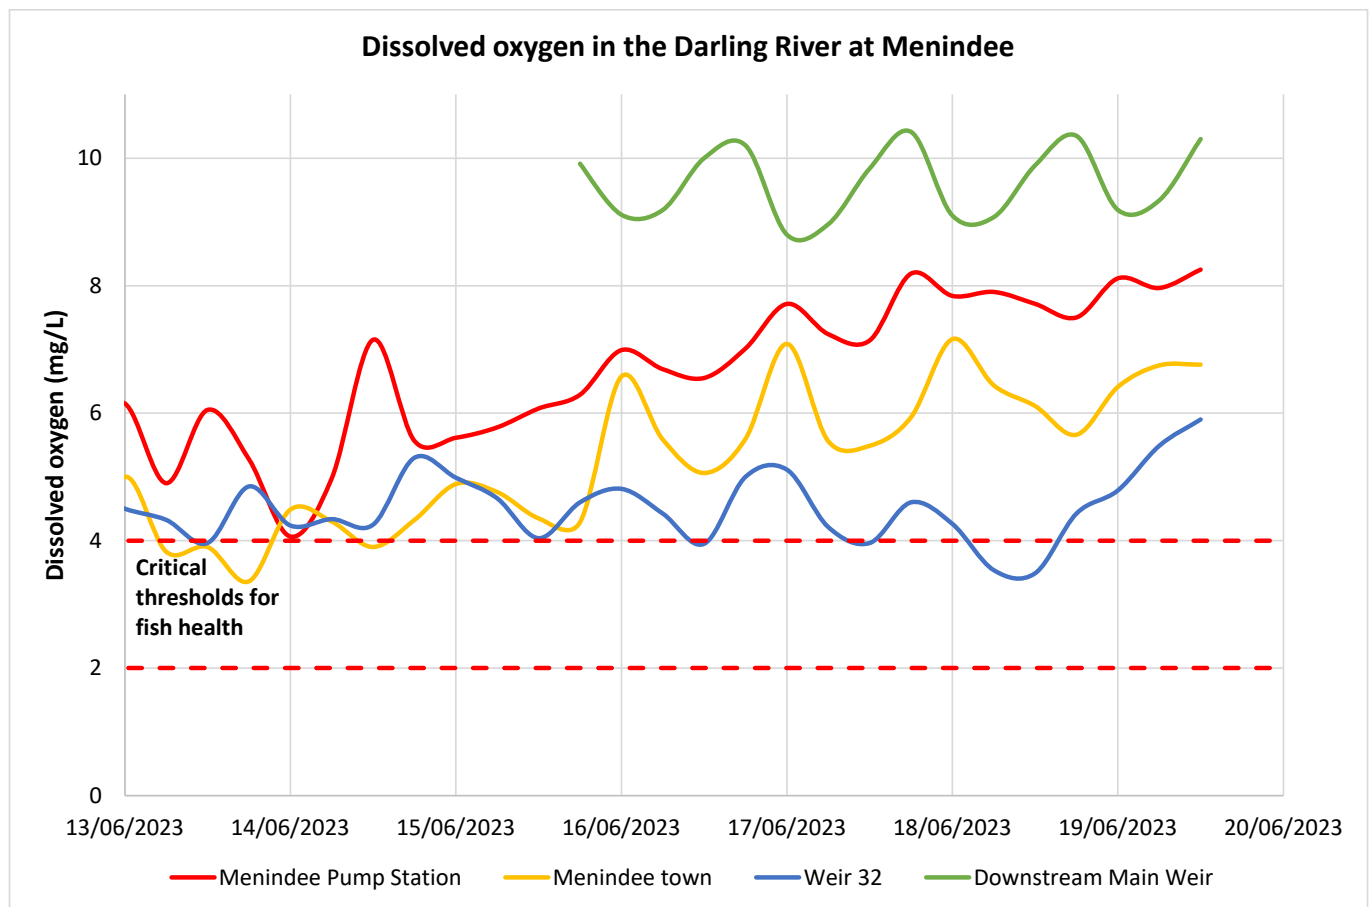
Data from WaterNSW dissolved oxygen sensors downstream of Lake Wetherell Main Weir, Menindee pump station, Menindee town, and further downstream at Weir 32, are shown in Figure 4. These sensors are set at various depths so may not always reflect the readings taken at the water surface. The new temporary sensor installed downstream of Lake Wetherell Main Weir is showing the water currently being released from Lake Pamamaroo is well oxygenated. Dissolved oxygen levels at the two sites near Menindee have been fluctuating from day to day. The sensor at the pump station is located closer to the water surface and is showing oxygen levels are remaining above the fish health threshold of 4 mg/L. The sensor at Menindee town is located closer to the riverbed (where dissolved oxygen levels can be lower than shallow areas) and had been recording oxygen levels less than the 4 mg/L threshold deeper in the water column. Oxygen levels have now improved above 4 mg/L.

Figure 4: Dissolved oxygen (mg/L) in the Darling River at Menindee: Menindee pump station, Menindee town and Weir 32 – 12 to 19 June 2023

Releases from lakes Pamamaroo and Menindee have been reduced to further preserve the water resource but still maintain flows above operational flow targets at Weir 32. Monitoring is showing an area of low oxygen water immediately upstream of the Darling River-Menindee Creek junction. The results from Weir 32 show reducing the releases from Lake Menindee is drawing some of this low oxygen water from the Darling River upstream of Menindee Creek downstream, which has caused dissolved oxygen levels at Weir 32 to decline to 4 mg/L on some days. Further decreases in dissolved oxygen between Menindee Creek and Weir 32 pose additional risk of fish deaths.
