Ecohealth

A health check for our waterways

Macleay Catchment REPORT CARD 2016

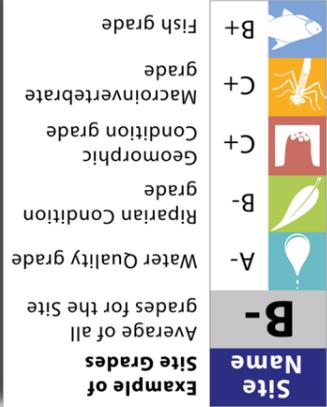
Ecohealth scoring and grading

The diagram to the right shows the Ecohealth grading system, where a grade is given for water quality, riparian condition, geomorphic condition, aquatic macroinvertebrates, and fish. Based on the overall grade is awarded to the site. Overall grades are then also awarded for each river system, subcatchment, and for all freshwater and estuarine sites.

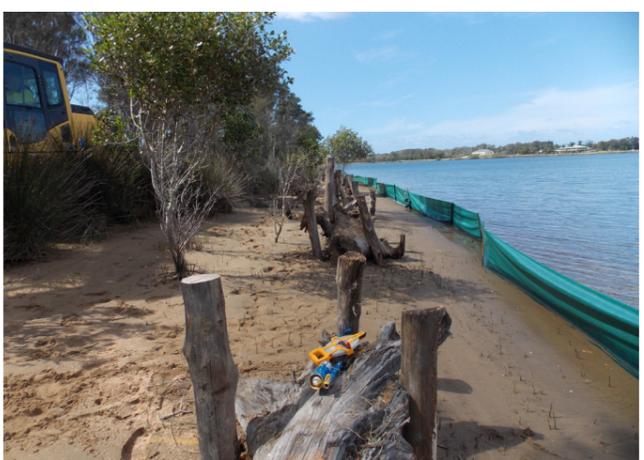
Pelican Island rehabilitation project to improve foreshore habitat. Photo © R. Kemsley, KSC.

Kempsey Shire Council (KSC) in partnership with NSW OEH, Local Land Services, DPI Fisheries, Landcare and local landowners is implementing a number of riverine and estuarine rehabilitation projects. These include the Pelican Island foreshore habitat improvement project, The Boyters Lane/Spencers Creek riparian improvement project and the Sherwood/Macleay River riparian rehabilitation project.

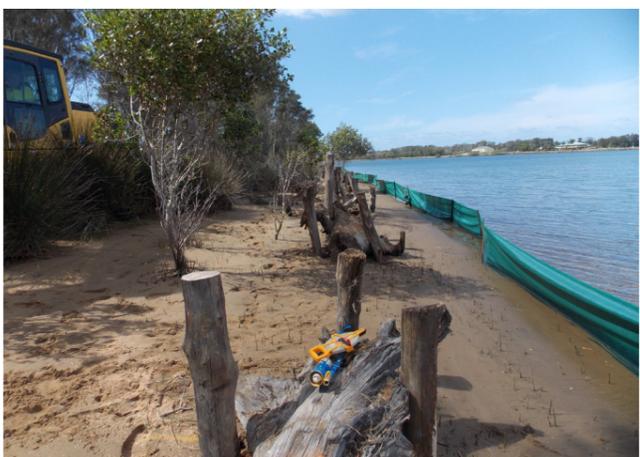
Pelican Island rehabilitation project to improve foreshore habitat. Photo © R. Kemsley, KSC.

Kempsey Shire Council (KSC) in partnership with NSW OEH, Local Land Services, DPI Fisheries, Landcare and local landowners is implementing a number of riverine and estuarine rehabilitation projects. These include the Pelican Island foreshore habitat improvement project, The Boyters Lane/Spencers Creek riparian improvement project and the Sherwood/Macleay River riparian rehabilitation project.
