Figure 2 – Removal of Emergency levee scenario

Figure 3 – Flood levels and ground levels taken in and around during 2022 floods by local Land Suurveyor (Note these are reduced levels not AHD)

## Proposed floodplain boundary and floodway network around

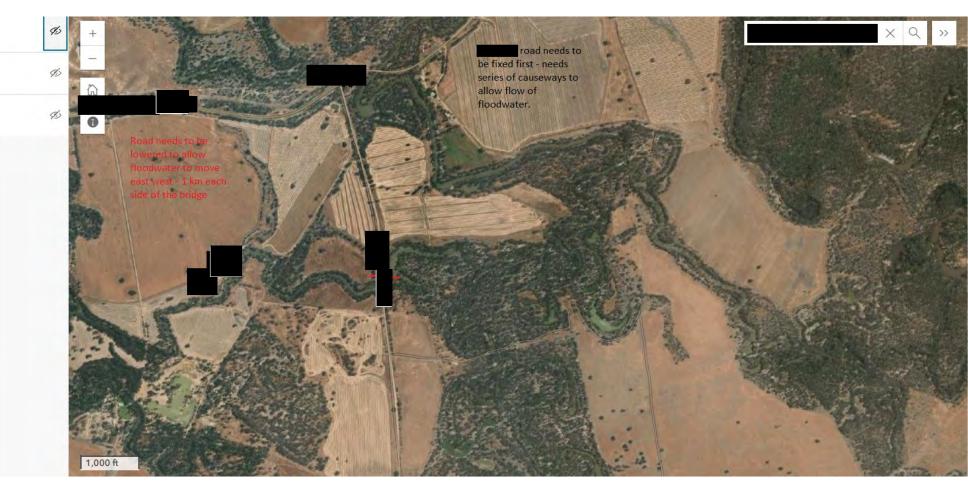
Expected levee breach points during moderate to high flood if Little Forest emergency levee removed

Direction of water travel

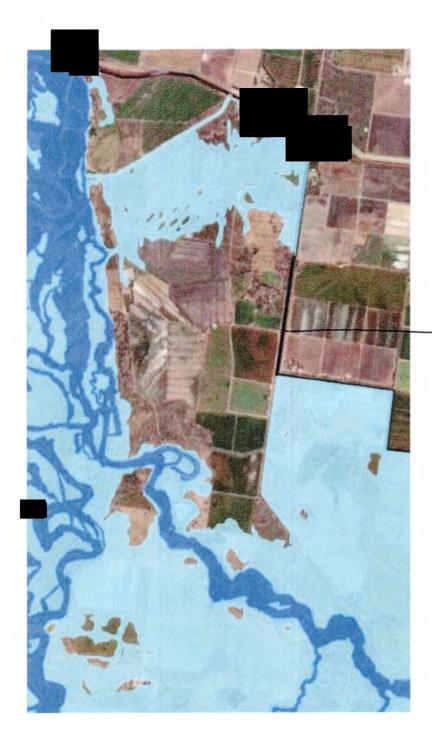
- BOUNDARY LINE IS NOT CORRECT

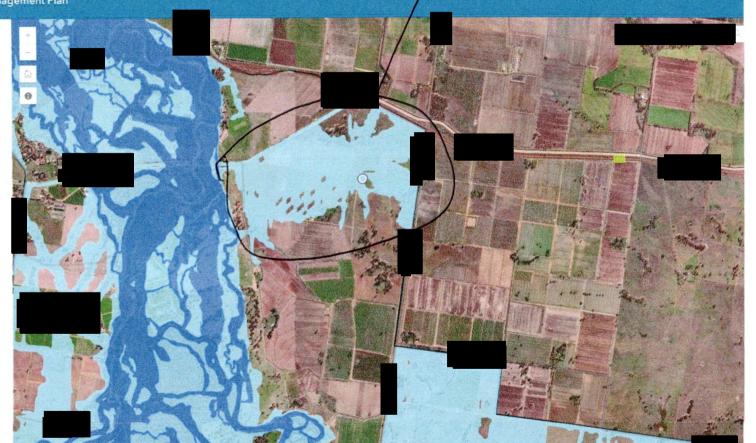
Heavy black line = proposed floodplain boundary

Dark blue = floodways

Pale blue = inundation extent or ponding areas

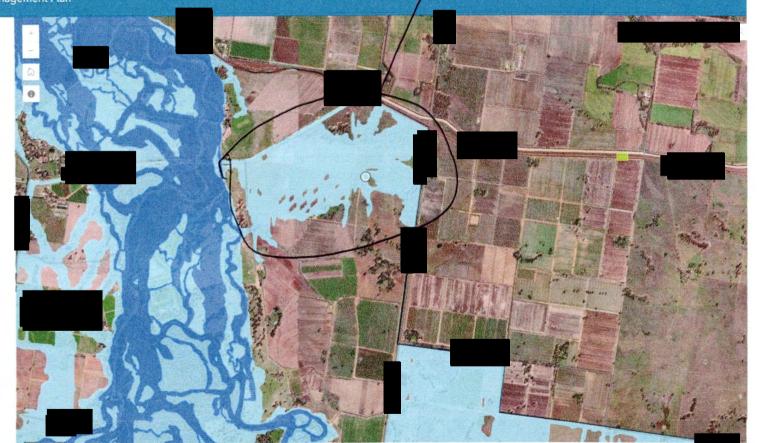
## Proposed floodplain boundary and floodway network around

Heavy black line = proposed floodplain boundary

Dark blue = floodways

Pale blue = inundation extent or ponding areas

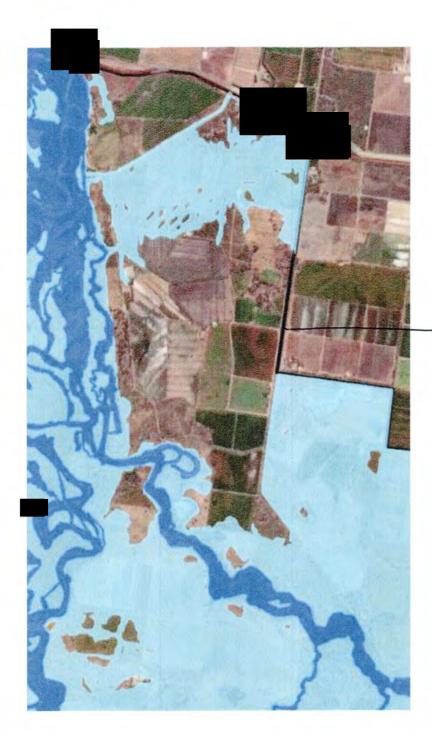
- BOUNDARY LINE IS NOT CORRECT

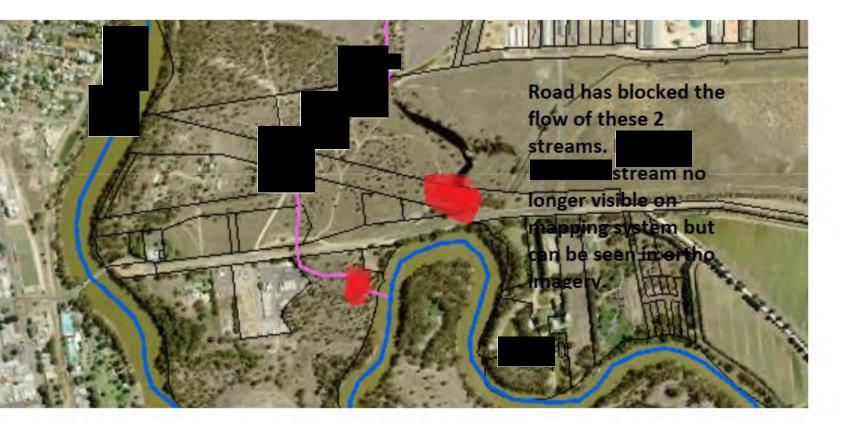
Length of road goes under during flood. To low and no causeway/culvets to manage water.
