Lower Darling River – water quality and flow release update

Following the mass fish deaths in the Darling River at Menindee in March 2023 multiple agencies are continuing to monitor water quality conditions in this area to identify potential risks to ecological communities, implement mitigating measures and minimise the risk of further fish death events. This update provides a summary of information and operational measures up to 22 December 2023.

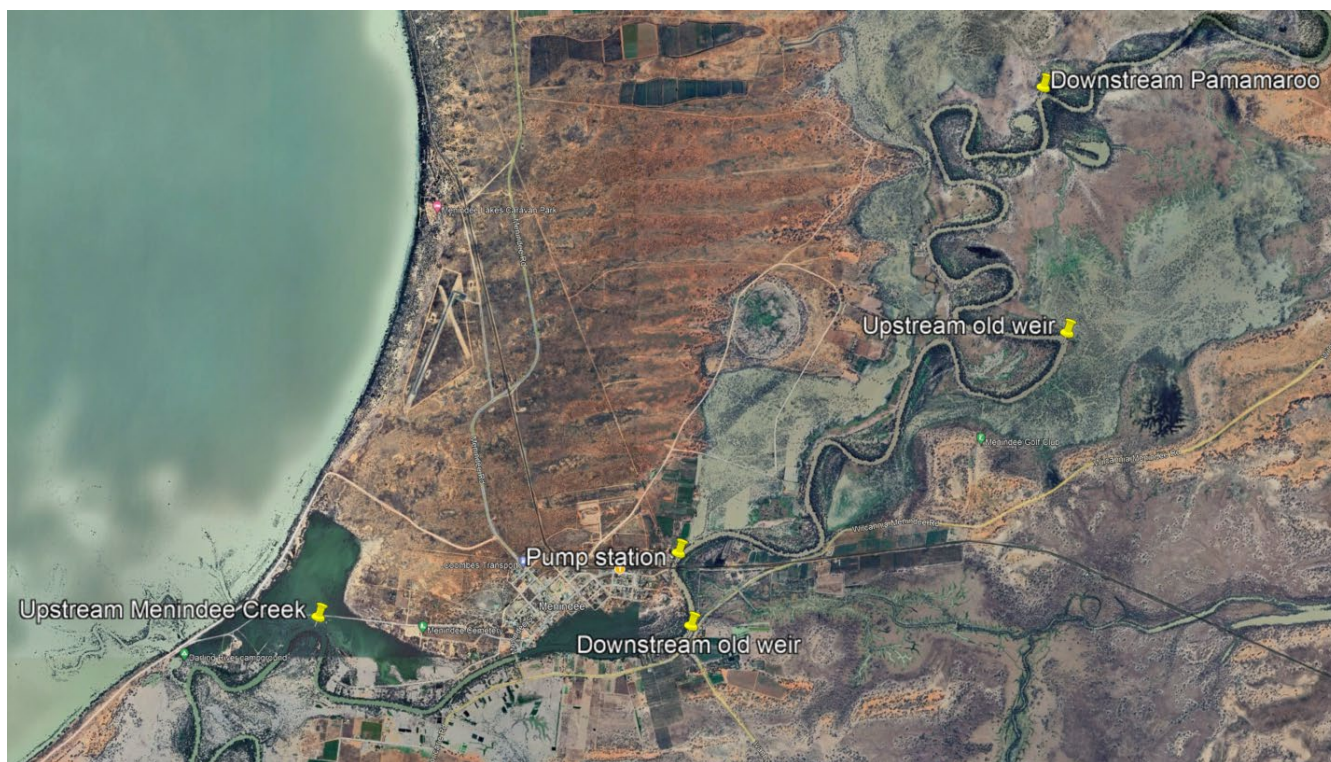
Figure 3: Location of vertical profile monitoring sites in the Darling River near Menindee.

The water temperature results were stable with depth indicating that there was thermal mixing throughout the water column (Figure 2). The location of the five sites assessed are shown in Figure 3.

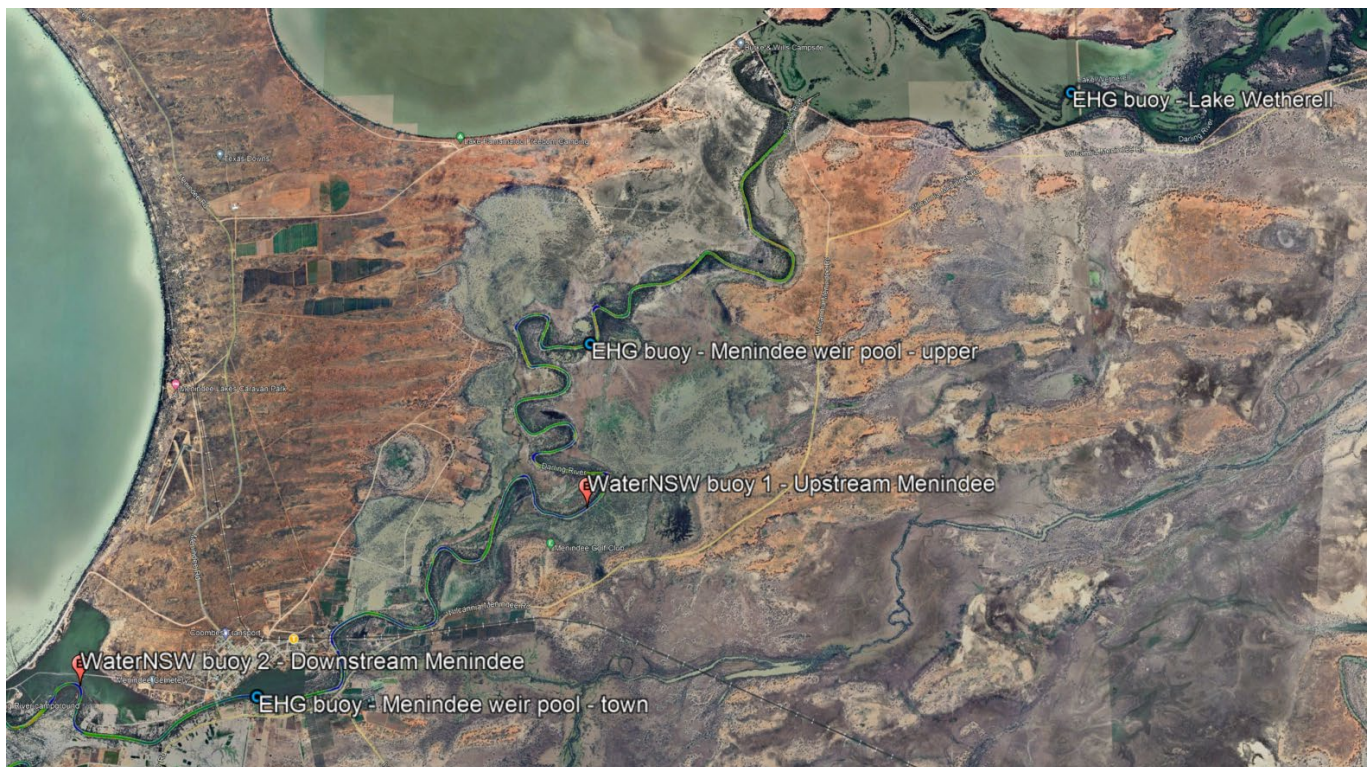
Figure 4: Locations of vertical profile water quality monitoring buoys at Menindee

Five multi-depth monitoring buoys have recently been installed in the Menindee area. These buoys monitor water quality at specific depths down through the water column. This data can be used to indicate when stratification starts, how long it has been present and if it has broken down, allowing the mixing of dissolved oxygen. The locations of the buoys are shown in Figure 4. The sites are:

- Lake Wetherell. Installed by Department of Planning and Environment – Environment and Heritage Group
- Darling River at Menindee weir pool – upper. Installed by Department of Planning and Environment – Environment and Heritage Group
- Darling River upstream Menindee. Installed by WaterNSW
- Darling River at Menindee weir pool – town. Installed by Department of Planning and Environment – Environment and Heritage Group
- Darling River downstream Menindee. Installed by WaterNSW.

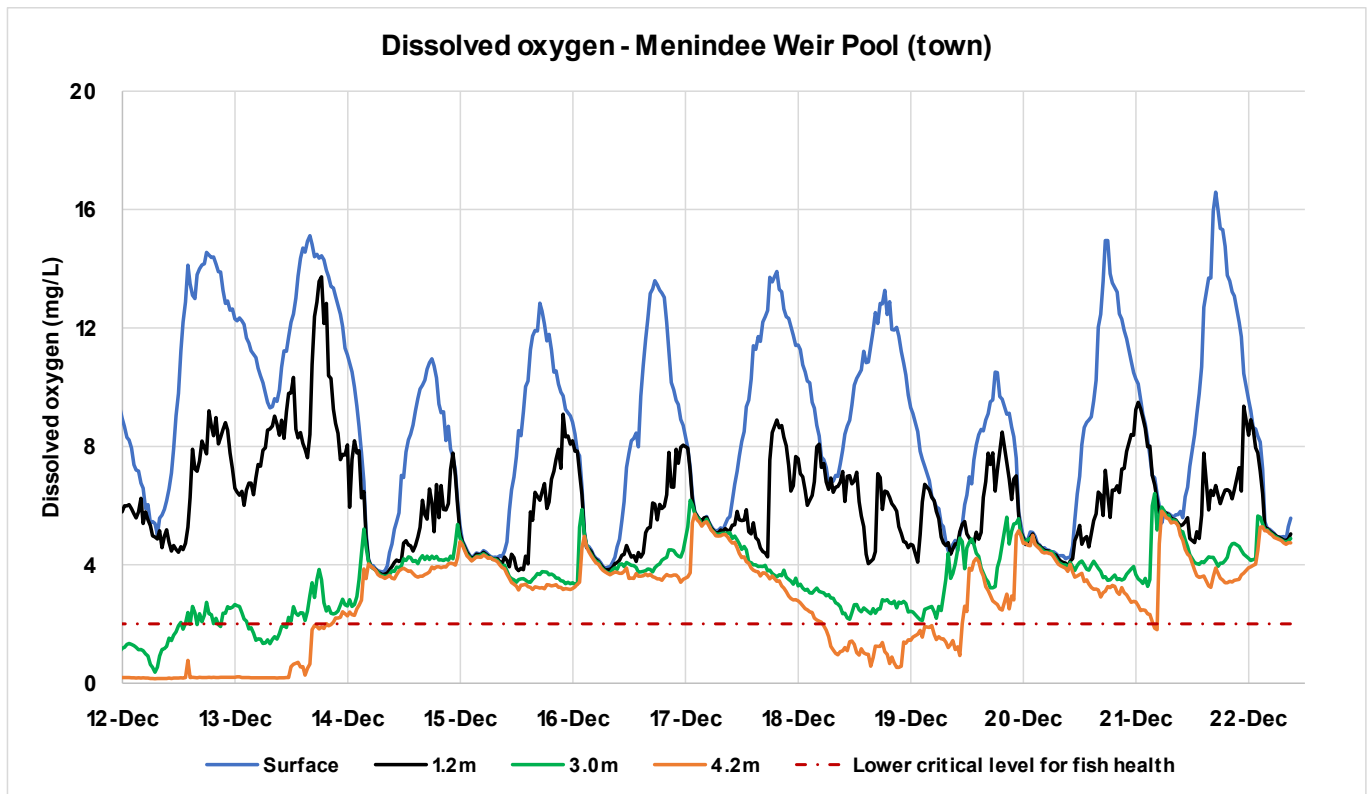
Figure 9: Dissolved oxygen (mg/L) continuous monitoring in the Darling River at Menindee weir pool (Town)

Similar to water temperature, the dissolved oxygen results also show stratification up until 14 December. The higher discharge of oxygenated water from Lake Pamamaroo until 18 December maintained dissolved oxygen levels above the critical threshold for fish health of 2 mg/L (Figure 8, Figure 9 and Figure 10).

Since 18 December, monitoring shows dissolved oxygen was again decreasing deeper in the water column. At the monitoring buoy near Menindee town, dissolved oxygen had been dropping below the 2 mg/L critical threshold for fish health at 4.2 metres. With the arrival of cooler air temperatures, dissolved oxygen was mixed through the water column on the morning of 20 December.

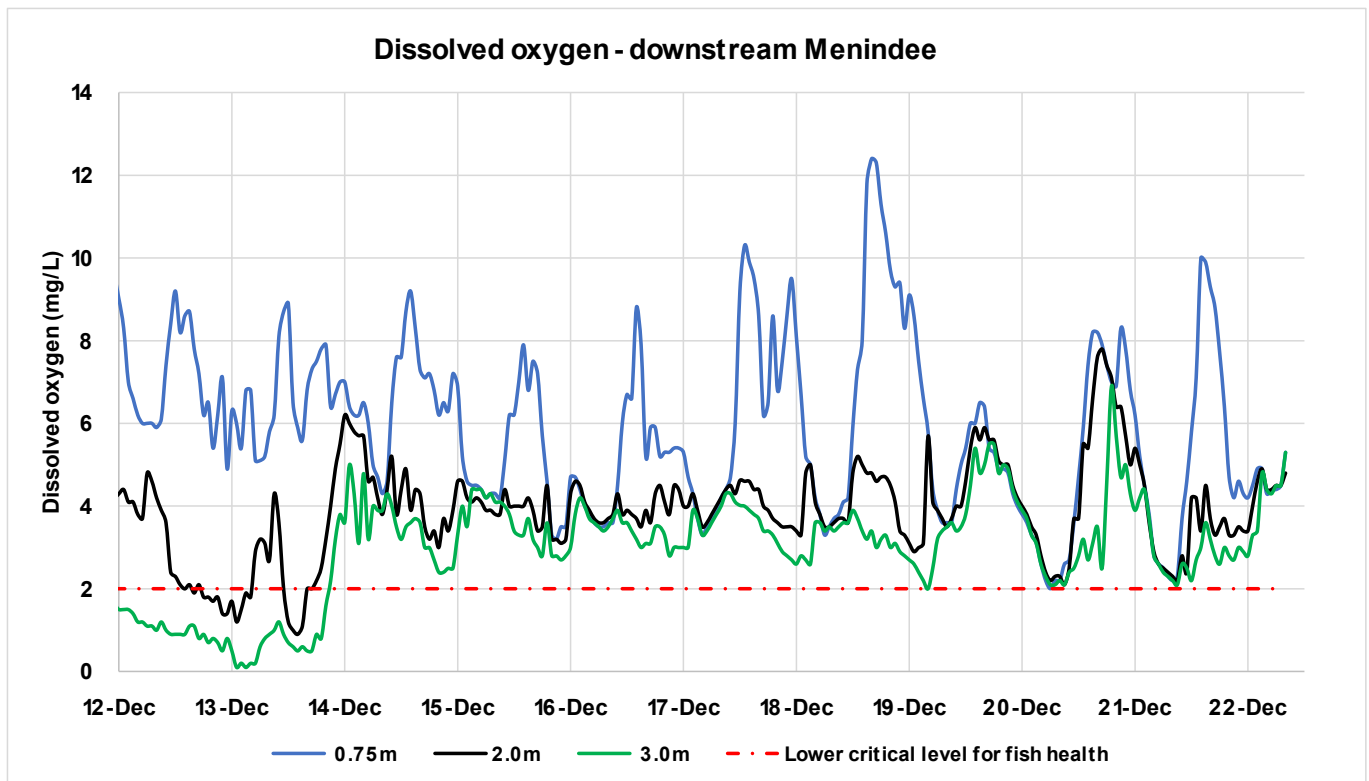
Figure 10: Dissolved oxygen (mg/L) continuous monitoring in the Darling River downstream of Menindee
