# Murray Darling Basin – water quality and dissolved oxygen results

Multiple agencies are undertaking water quality monitoring to review dissolved oxygen conditions across NSW, identify potential risks to ecological communities, implement mitigating measures and responding to the mass fish death event in the Darling River. This update provides a summary of information collected up to 5 April 2023.

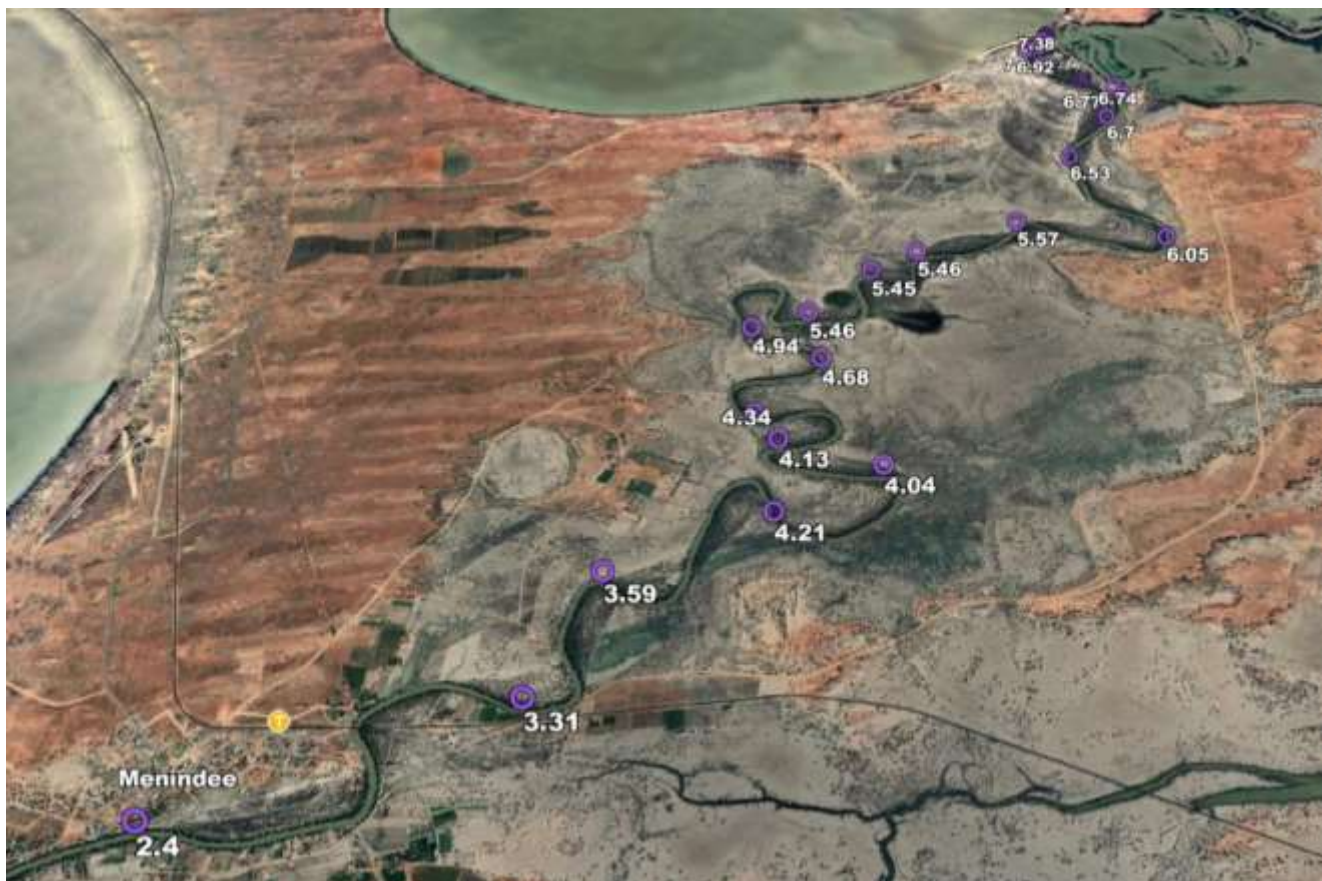
Figure 1 is a Google Earth image showing the location and results from the survey of dissolved oxygen levels down the Darling River on 5 April from Lake Pamamaroo to Menindee town. The results show that there was a gradual decrease in oxygen levels with distance down the Darling River, with the lowest result (2.4 mg/L) recorded at Menindee. Most of this reach of river had dissolved oxygen levels above the threshold of 4 mg/L.

Figure 1: Google Earth image showing dissolved oxygen results (mg/L) from the Lake Pamamaroo outlet to Menindee town – 5 April

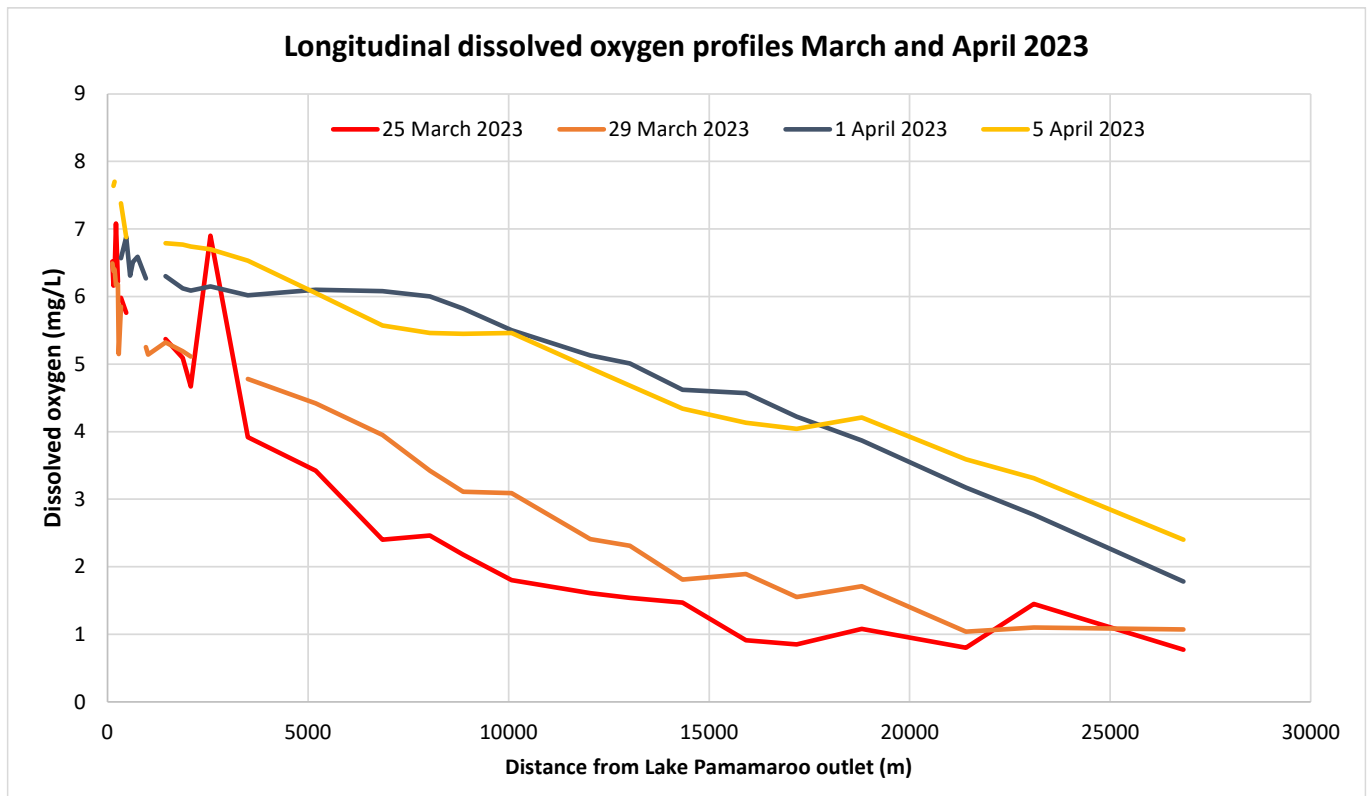
Four longitudinal surveys of dissolved oxygen have been undertaken down this reach of the Darling River over recent weeks (25 March, 29 March, 1 April and 5 April). Figure 2 compares these four sets of results and shows that, over time, dissolved oxygen levels have been improving in response to the operational measures in place.

Figure 2: Comparison of dissolved oxygen results (mg/L) from the Lake Pamamaroo outlet to Menindee town collected on 25 March, 29 March, 1 April and 5 April 2023

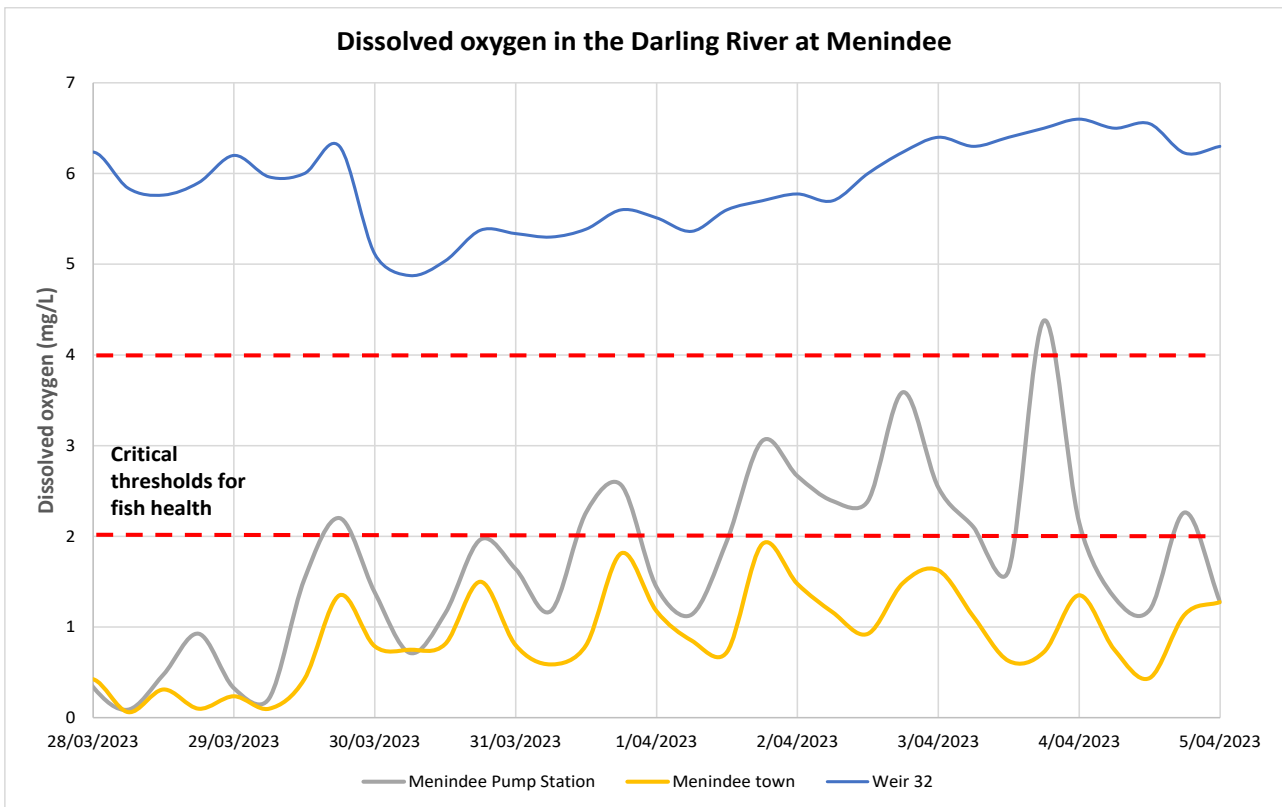
Data from WaterNSW dissolved oxygen sensors at the Menindee pump station, Menindee Town, and further downstream at Weir 32 are shown in Figure 3. These indicate daily fluctuations in dissolved oxygen, with replenishment during the day but decreasing overnight. Dissolved oxygen levels at Weir 32 are above the critical thresholds for fish health, highlighting that the release of oxygenated water from lakes Menindee and Pamamaroo is mixing with, and replenishing oxygen levels in the water progressing down the Darling River from Menindee.

Figure 3: Dissolved oxygen (mg/L) in the Darling River at Menindee: Menindee pump station, Menindee town and Weir 32 – 28 March to 4 April 2023

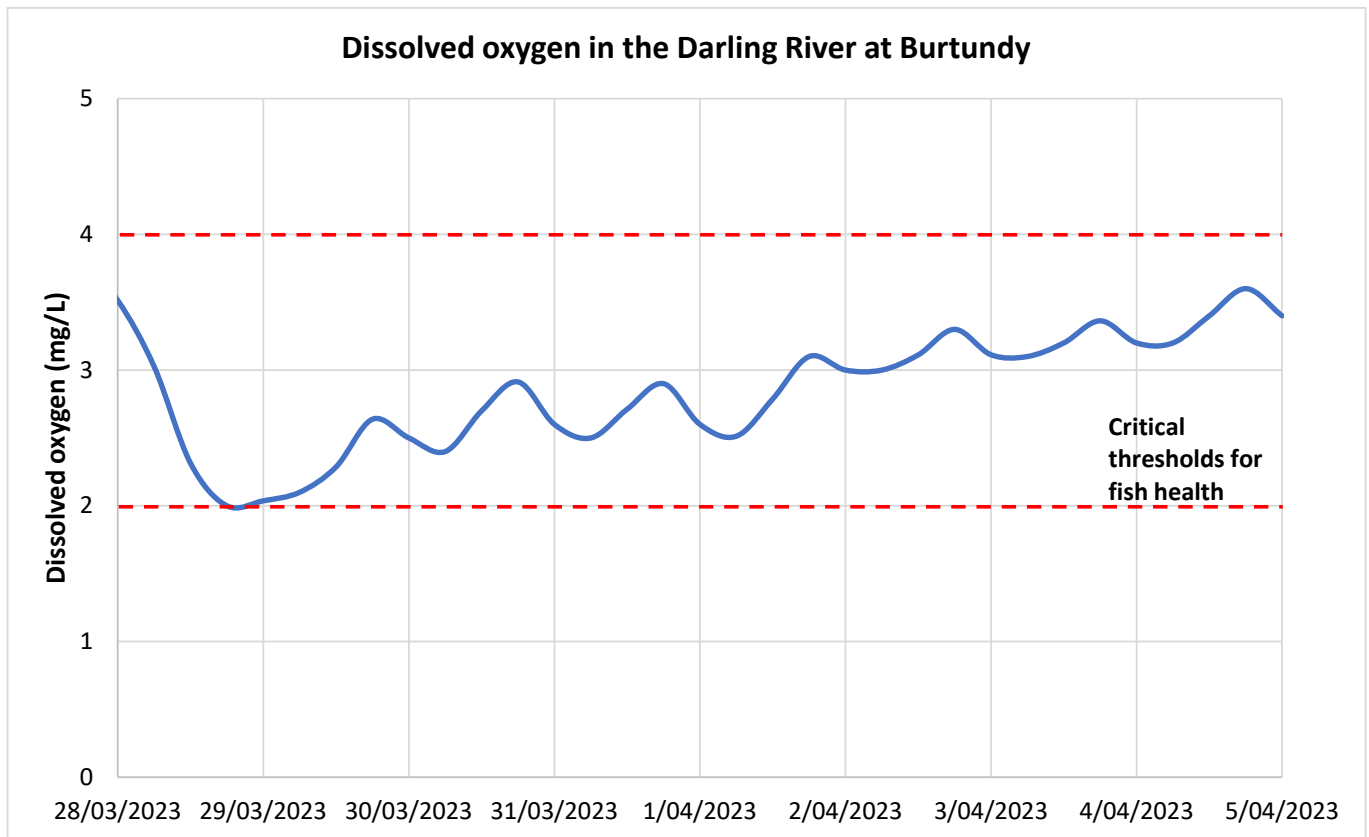
Table 1 shows recent dissolved oxygen data in the lower Darling River from Moorara (upstream of Pooncarie) down to Tapio in the Wentworth weir pool. Critical readings below 2 mg/L have been highlighted in red. Figure 4 shows dissolved oxygen results for the Darling River at Burtundy over the last 8 days. Dissolved oxygen has been slowly improving toward 4 mg/L.

Figure 4: Dissolved oxygen (mg/L) in the Darling River at Burtundy – 28 March to 4 April 2023
